NISTIR 6923

Simulation of the Dynamics of a Fire in a One-Story Restaurant --Texas, February 14, 2000

October 2002

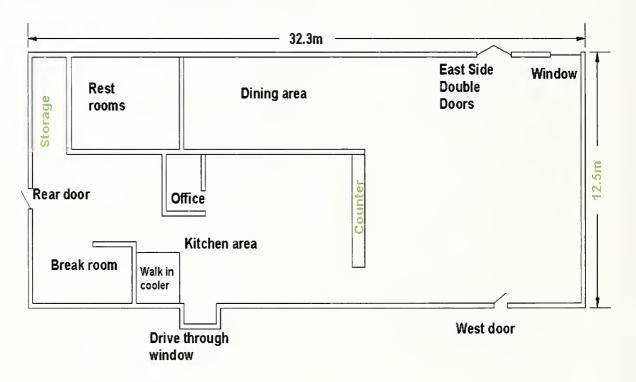
On the morning of February 14, 2000, a fire started in the office area of a fast food restaurant. Figure 1 and Figure 2 show the office area of a similar restaurant. At 4:30 AM the fire department received a call from a civilian who reported that fire was emanating from the roof of the restaurant. At 4:37 AM the first fire department apparatus arrived on the scene and confirmed that fire was visible from the roof, Figure 3. Shortly after arrival, two fire fighters from the first arriving fire apparatus, entered the structure using a door located on the west side in an effort to locate and extinguish the fire. Other firefighters

Figure 3. Early stages of the fire.

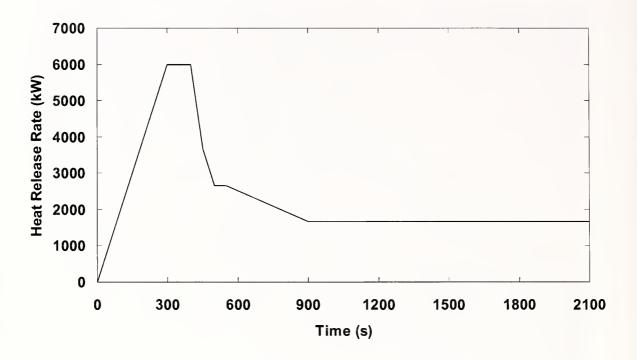
Figure 7. Heat release rate for the ignition source.

This ignition source covered an area of 2.8 m² (30 ft²) and was located 0.50 m (20 in) above the floor. The peak heat release rate for this ignition source was 6.0 MW. The heat release rate of this ignition source is assumed to grow linearly and reach its peak of 6.0 MW after 300 s. This peak heat release rate is maintained until 400 s into the simulation at which time it decreases in several stages to 1.6 MW. This final heat release rate is maintained for the duration of the simulation. Figure 7 is a graph of the heat release rate for this fuel package versus time.

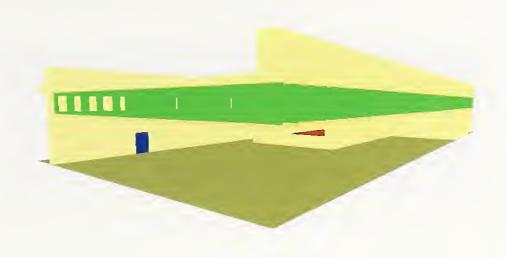
Figure 8. Smokeview representation of the restaurant from the west side.

Figure 8 shows the restaurant representation from the Smokeview computer program. The view is from the west side of the structure. The door used by the initial entry team can be seen in blue. The positive pressure ventilation fan is in green and is positioned outside the entry door. The initial collapse zone used in this simulation is shown as a blue square on the roof of the structure. The light blue structure toward the left of the figure is the drive through window. Figure 9 shows the model viewed from the south. The south and east walls have been removed to show the interior. To the left of the figure is the door used by the initial entry team. The red area to the rear of Figure 9 represents material from the roof

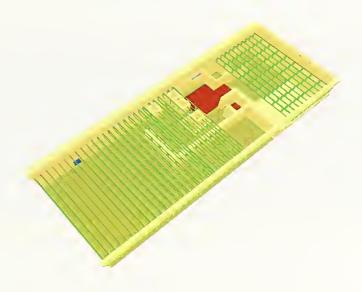
Figure 9. View from the south side with the south and east walls removed.

and ceiling that has fallen to the floor. Figure 10 is a view of the restaurant from above. The roof and ceiling have been removed to view how the trusses are modeled. Additionally, some of the trusses have been removed in order to see the structures below them. The larger of the two red areas located in the interior of the restaurant represents the roof and ceiling materials that fell to the floor. The smaller red area in the small room to the right and down from the collapse zone is the office where the fire started.

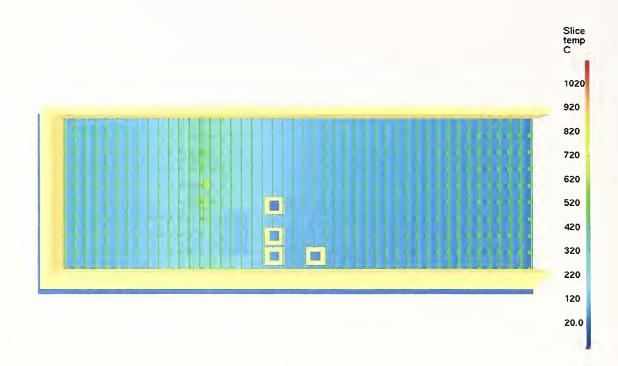
Figure 11 shows a horizontal slice of the temperatures within the attic space at 300 s into the simulation. A slice contains the data within a rectangular array of grid points. In this case the data of interest are the gas temperatures. The color bar to the right represents the corresponding numerical values. This figure shows that the temperature of the gases in the area of the attic just above the office is approximately 400 °C (750 °F). These hot gases appear to be spreading more toward the east and west sides (the short sides) of the structure rather than the north and south sides (the long sides). Figure 12 shows the same slice of the attic area after 1500 s of simulation, the approximate arrival time of the fire department. The majority of the attic space is in the range of 400 °C to 500 °C (750 °F to 930 °F). The area of the ceiling collapse in the office can be seen as a definite red square. This corresponds to a temperature of approximately 1000 °C (1800 °F).

Figure 11. Temperatures in the attic area at 300 s into simulation.

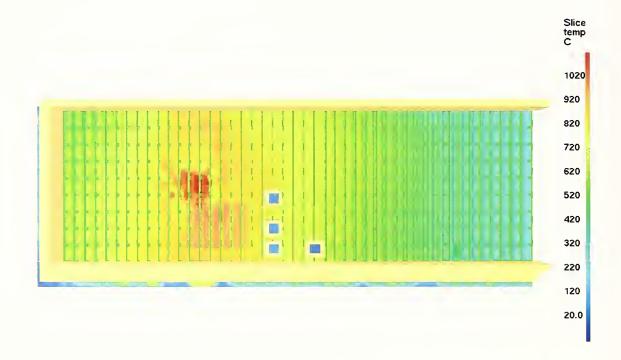
Figure 13 and 14 show the oxygen concentration within the attic at the same simulation times as Figures 11 and 12. Figure 12 and Figure 14 depict high temperature and low oxygen concentration within the attic area of the restaurant at approximately the time the fire department arrived. This would indicate there is little actual burning within the attic, except where the flames from the office area enter the attic and along the edges of the structure where the hot gases mix with fresh air and ignite. Even though there may not have been flames within a large part of the attic area, the gases themselves were hot enough to allow the wood trusses to pyrolize.

Figure 12. Temperatures in the attic area at 1500 s into simulation, the approximate time of arrival of the first fire department apparatus.

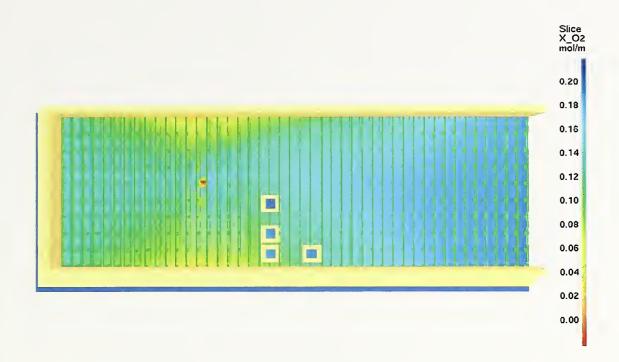
Figure 13. Oxygen concentrations in the attic area at 300 s into simulation.

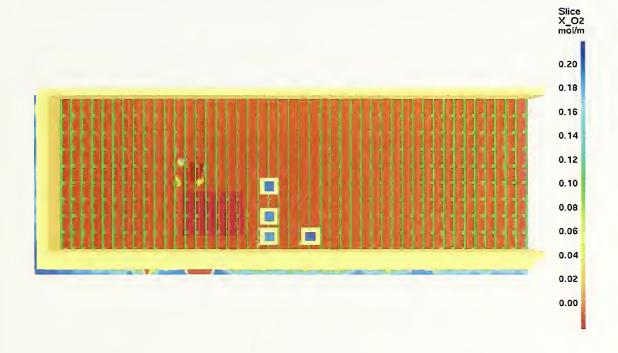
Figure 14. Oxygen concentrations in the attic area at 1500 s into simulation, the approximate time of arrival of the first fire department apparatus.

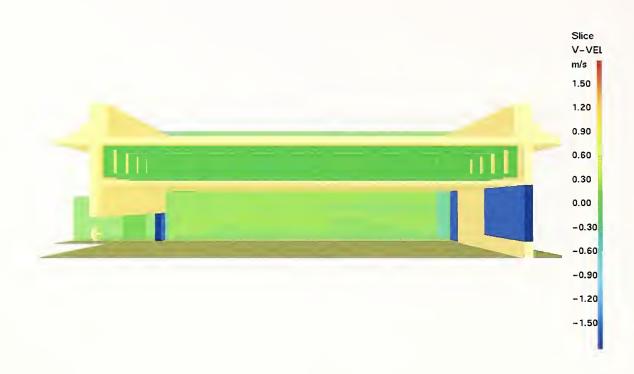
Figure 15 shows the gas velocity in a vertical plane that passes through the doors on the east and west side of the restaurant. The blue squares on the right and left of the figure represent the doors. The color bar on the right shows the magnitude of the gas velocity parallel to the plane. At 1615 s into the simulation the doors are closed and there is no appreciable flow of gases from one door to the other. Figure 16 shows the gas velocities at 1630 s, after the lower half of the west side door was opened. The red color shows air flowing into the structure from left to right at approximately 1.0 m/s to 1.5 m/s (3.0 ft/s to 5 ft/s). Gas velocities that are positive move from left to right in the figure. Figure 17 shows the gas velocities at 1705 s when the double door on the east side had been opened. The blue color shows air entering the restaurant from the right. Figure 18 shows the gas velocity at 1745 s into the simulation, which was 5 s after the start of the PPV fan. By that

Figure 15. Gas velocities at 1615 s into the simulation, before the west or east side doors were opened. Gas velocities within the plane are essentially zero.

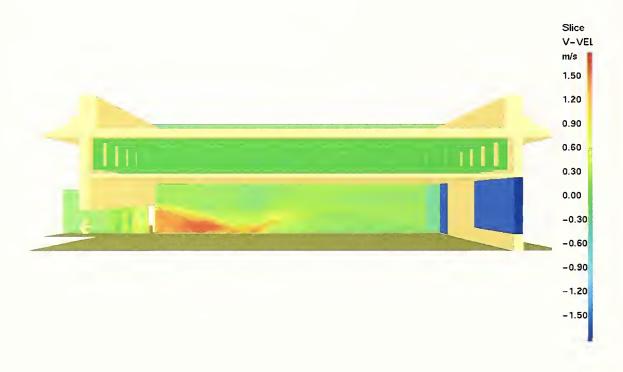
Figure 16. Gas velocities within a vertical plane at 1630 s, after the lower half of the west side door is opened. The red shows air flowing into the structure from left to right.

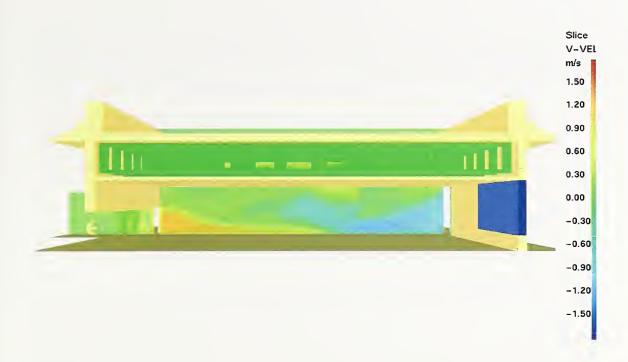
Figure 17. Gas velocities within a vertical plane at 1705 s into the simulation. The double door has been opened on the east side. The blue indicates air moving right to left into the structure.

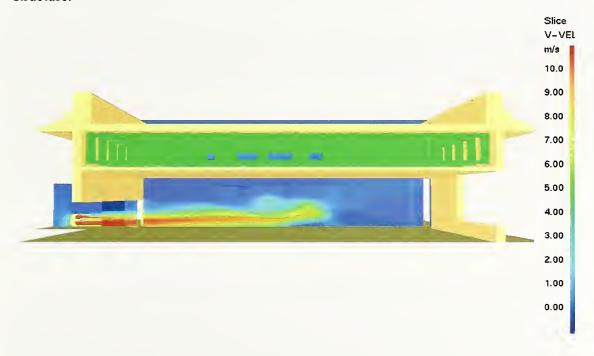
Figure 18. Gas velocities within a vertical plane at 1745 s into the simulation. PPV fan was activated at 1740 s into the simulation. Note the scale difference between this figure and Figure 15 through Figure 17.

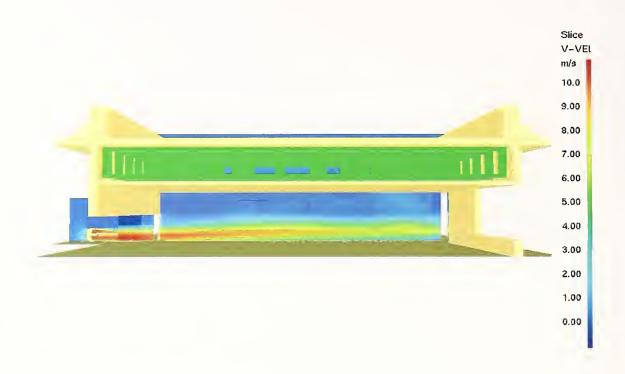
time the window on the east side had also been opened. It appears that much of the flow caused by the fan results in flow out of the restaurant through the double doors in the opposite wall Figure 19.

Figure 19. Gas velocities within a vertical plane at 1750 s into the simulation. Note the scale difference between this figure and Figure 15 through Figure 17.

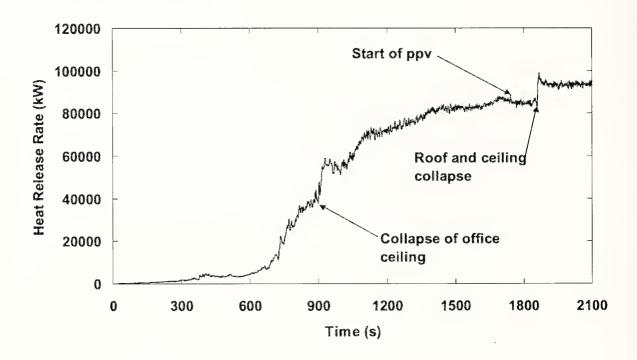
A measure of the intensity of a fire is the amount of heat that is being generated or released by the fire. Figure 20 is a graph of the heat release rate of the fire. From this graph it appears that the ceiling collapse in the office at 900 s and the roof/ceiling collapse at 1860 s into the simulation had a much greater and sustained impact on the heat release rate than the use of positive pressure ventilation.

Figure 20. Heat release rate for simulation.
